SUBJ: EPA Asbestos Removal at 215 Crane Street

REMOVAL ACTION STATUS REPORT DAVIDSON ASBESTOS

Property Address: 215 Crane Street, Davidson, Mecklenburg County, North Carolina

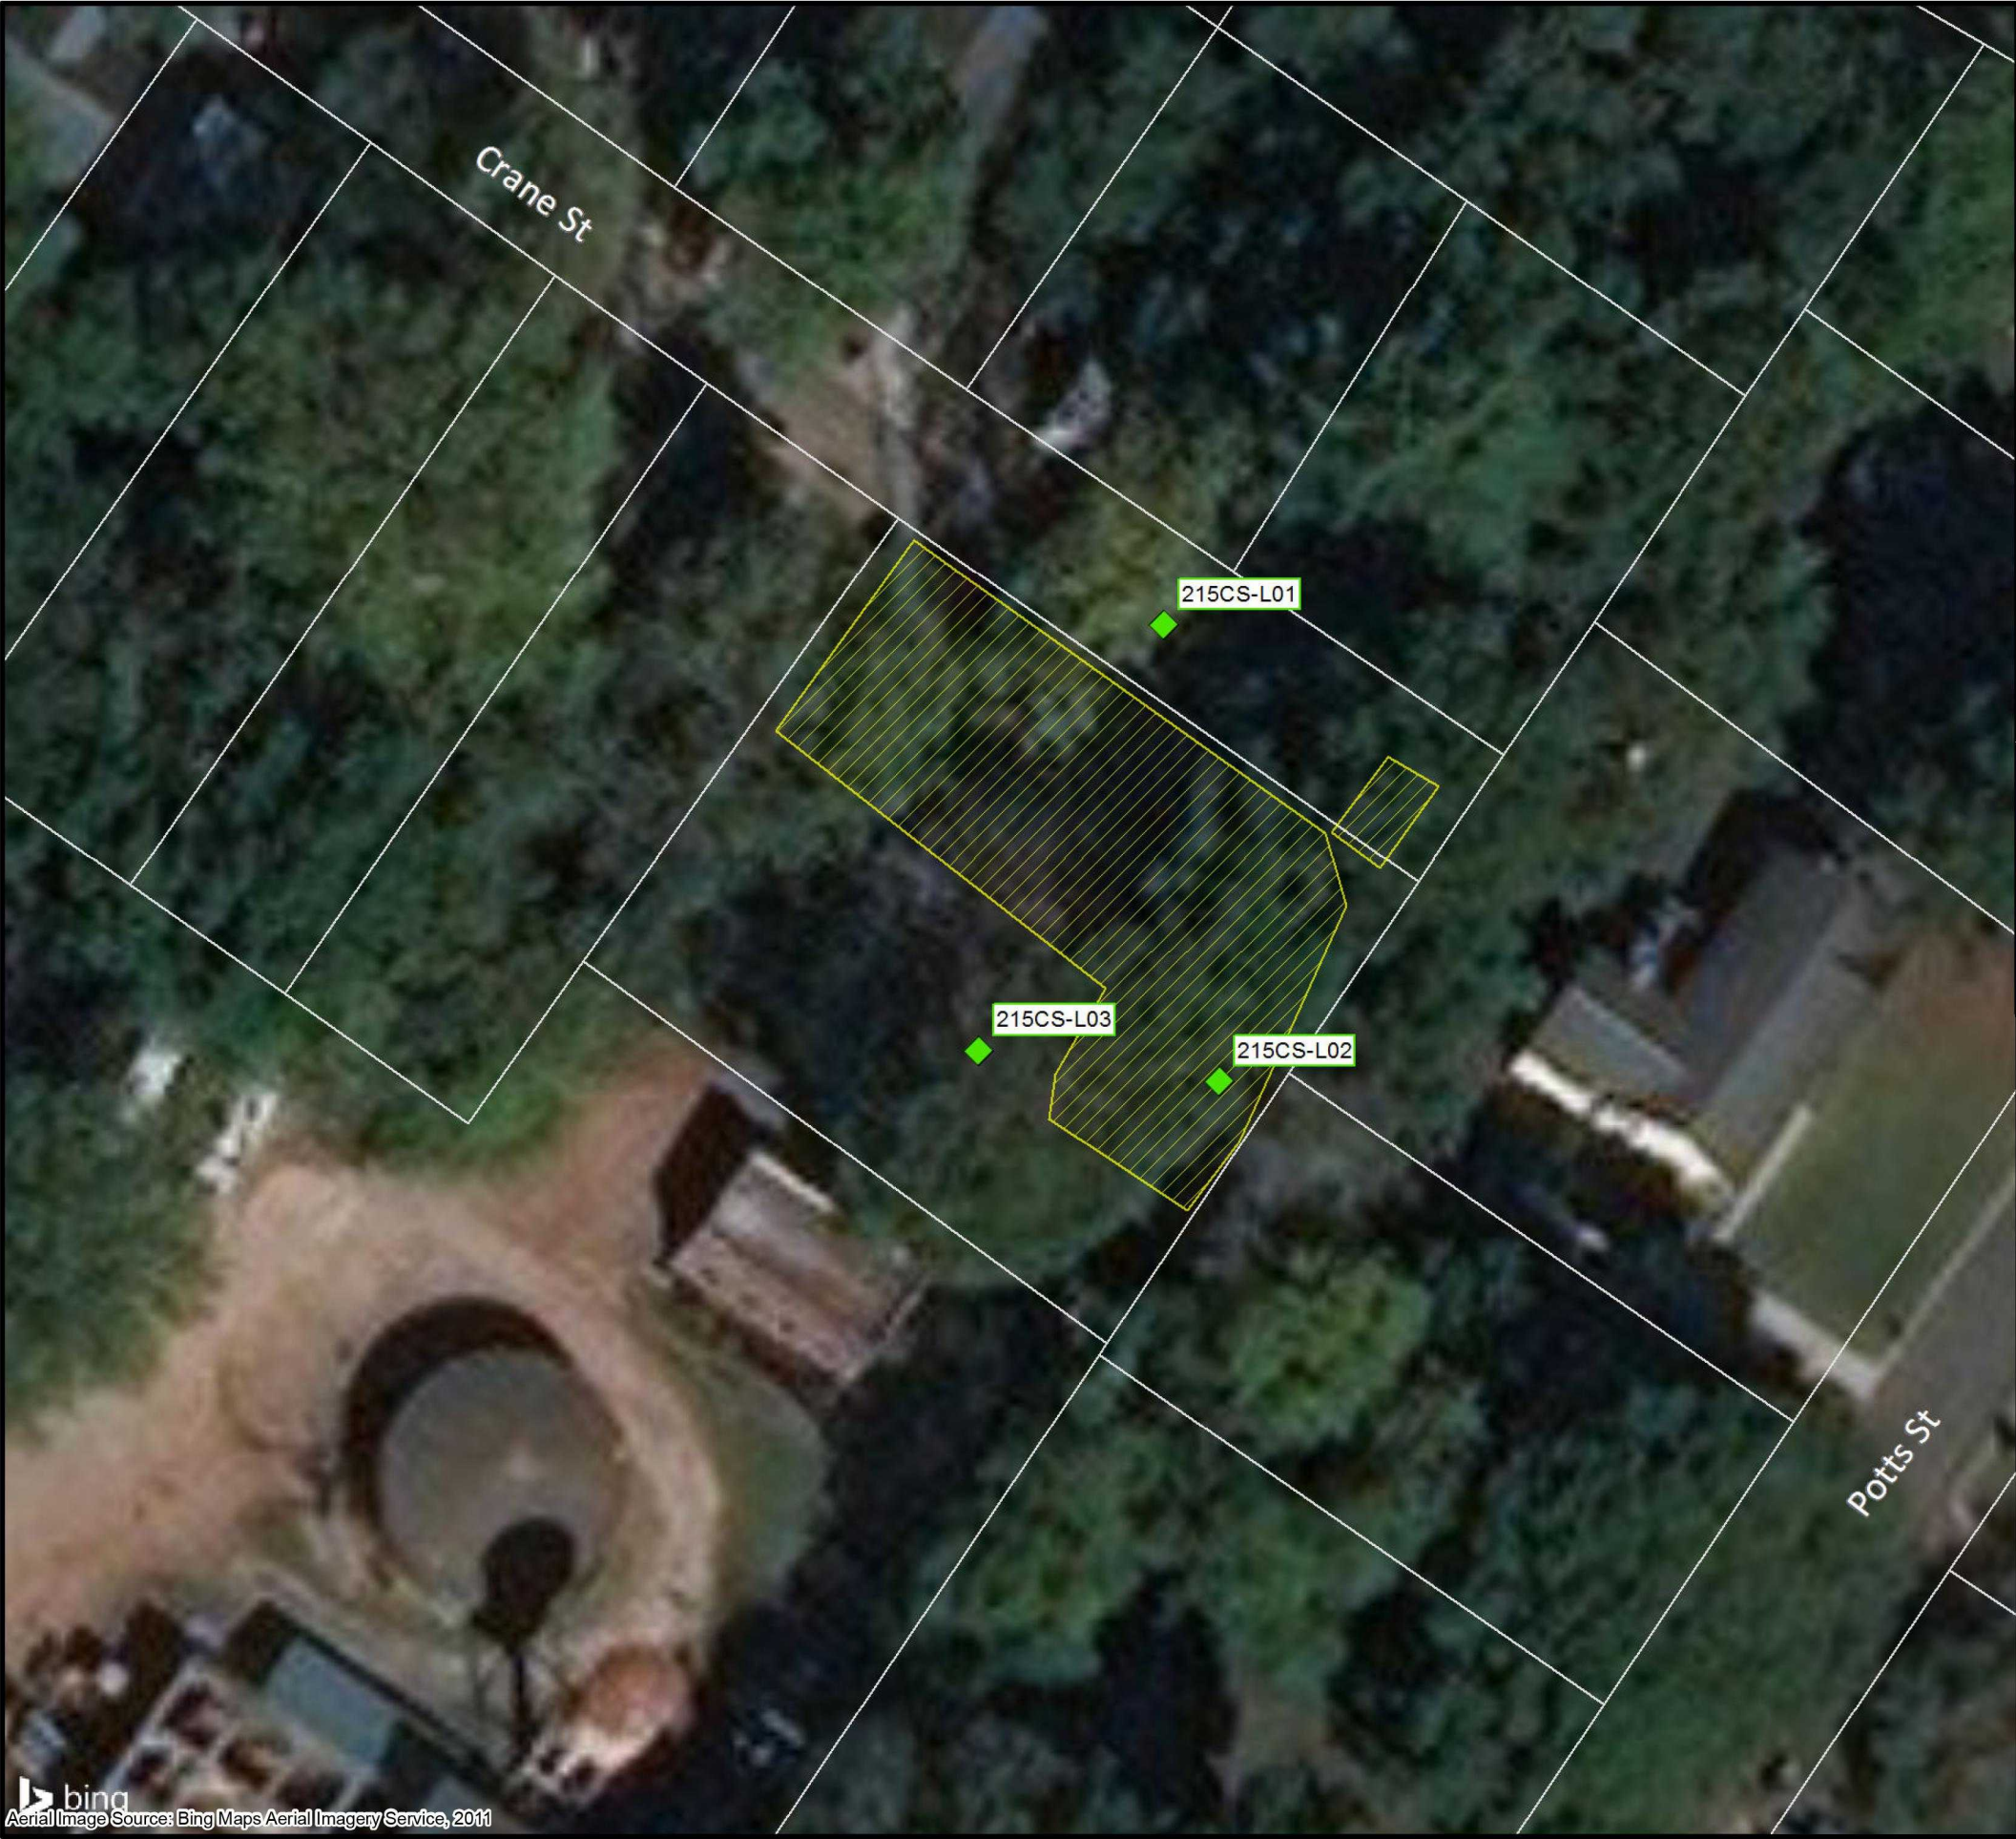
FIGURE 1

Removal Areas and
Air Sampling Locations

Description of Removal Action: The soil was excavated to an approximate maximum depth in the following areas: open area to 12 inches and tree line areas to 3 inches; and small area at the southeastern end of Crane Street to 3 inches (see Appendix 1). Visual inspections of the areas excavated for asbestos-containing materials (ACM) were conducted by a State of North Carolina-accredited asbestos inspector and air monitor. Additional removal was conducted in those areas where ACM were still visibly present. Once ACM was no longer visibly present, restoration of the excavated areas was allowed to commence.

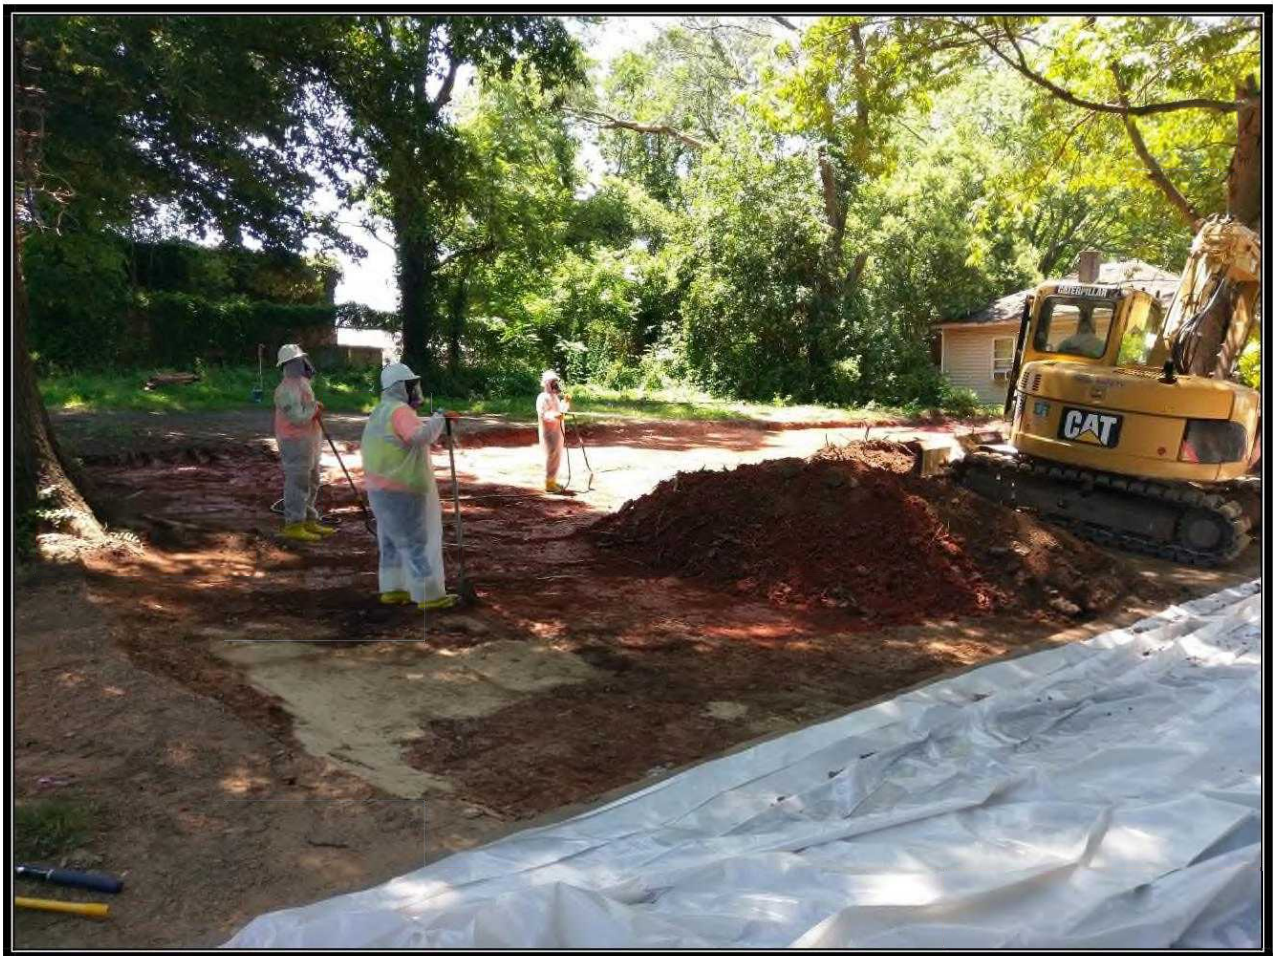
OFFICIAL PHOTOGRAPH NO. 1
U.S. ENVIRONMENTAL PROTECTION AGENCY

Subject: The Emergency and Rapid Response Services (ERRS) contractor, Environmental Restoration, LLC (ER), used an excavator and hand tools to remove asbestos-containing materials (ACM) and asbestos-contaminated soil from the property located at 215 Crane Street. ER used hoses to wet the asbestos-contaminated soil during removal activities.

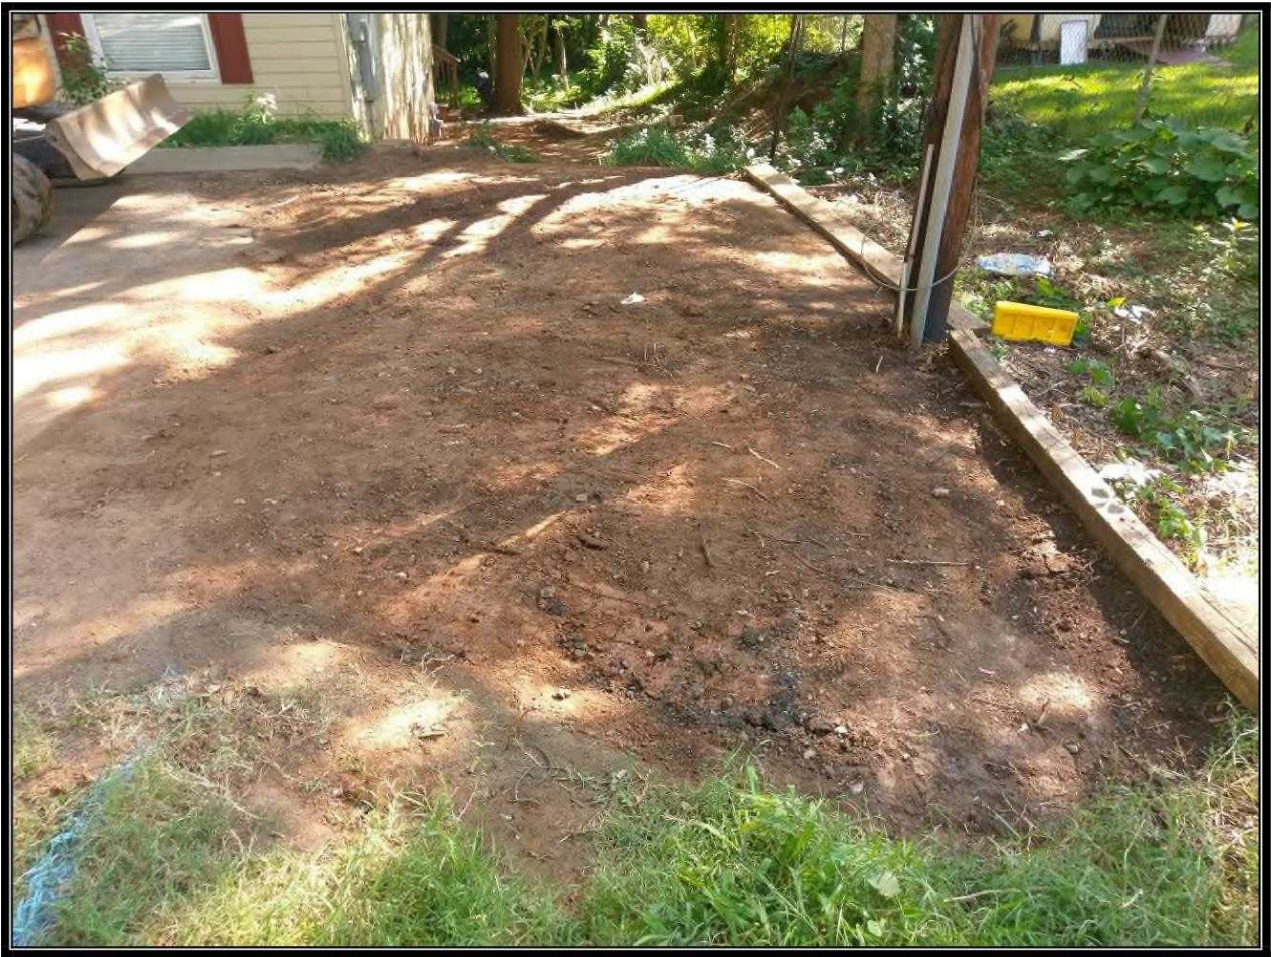
OFFICIAL PHOTOGRAPH NO. 2
U.S. ENVIRONMENTAL PROTECTION AGENCY

Subject: ER used an excavator and hand tools to remove ACM and asbestos-contaminated soil from the small area located at the southeastern end of 215 Crane Street. ER used hoses to wet the asbestos-contaminated soil during removal activities.

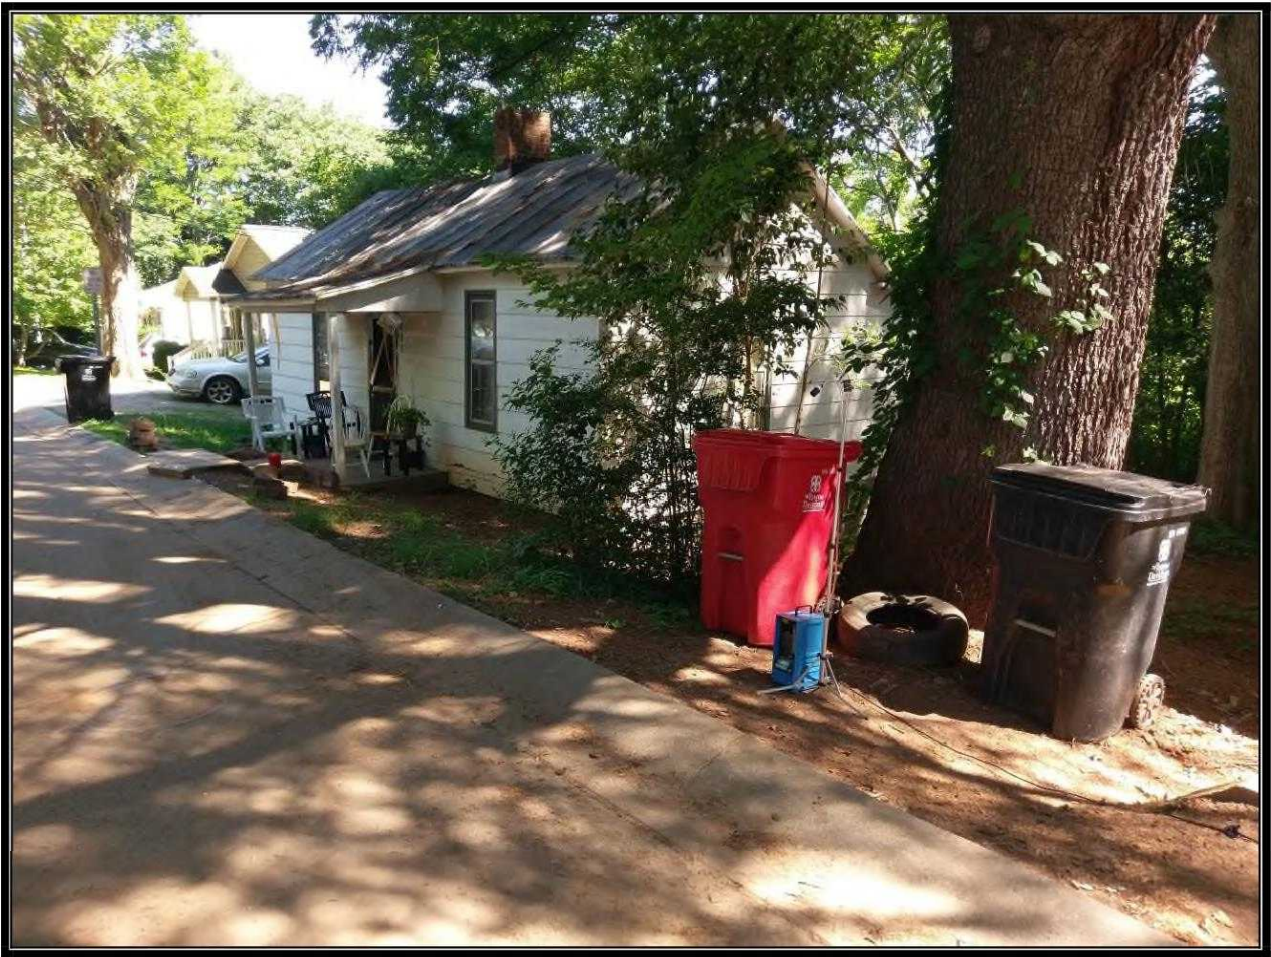
OFFICIAL PHOTOGRAPH NO. 3
U.S. ENVIRONMENTAL PROTECTION AGENCY

Subject: Perimeter air sampling was conducted by a Tetra Tech START, State of North Carolina-accredited air monitor, to evaluate the effectiveness of engineering and safety controls in preventing the off-site migration of asbestos fibers during removal activities.

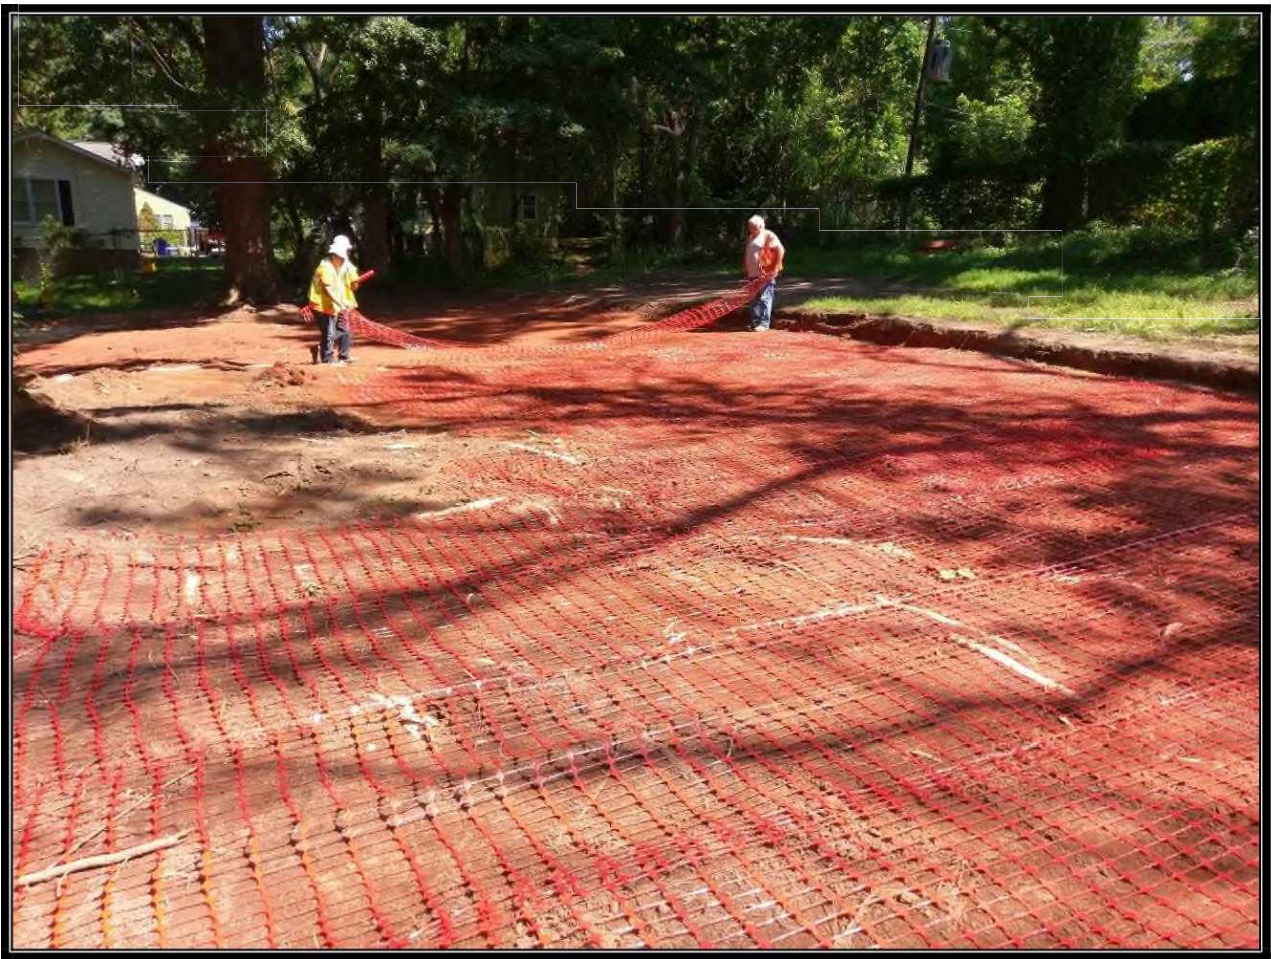
OFFICIAL PHOTOGRAPH NO. 4
U.S. ENVIRONMENTAL PROTECTION AGENCY

Subject: ER installed snow fencing along the subsurface of the excavated areas after the visual inspection conducted by Tetra Tech START, State of North Carolina-accredited asbestos inspector and air monitor, detected no visible ACM in the excavated area.

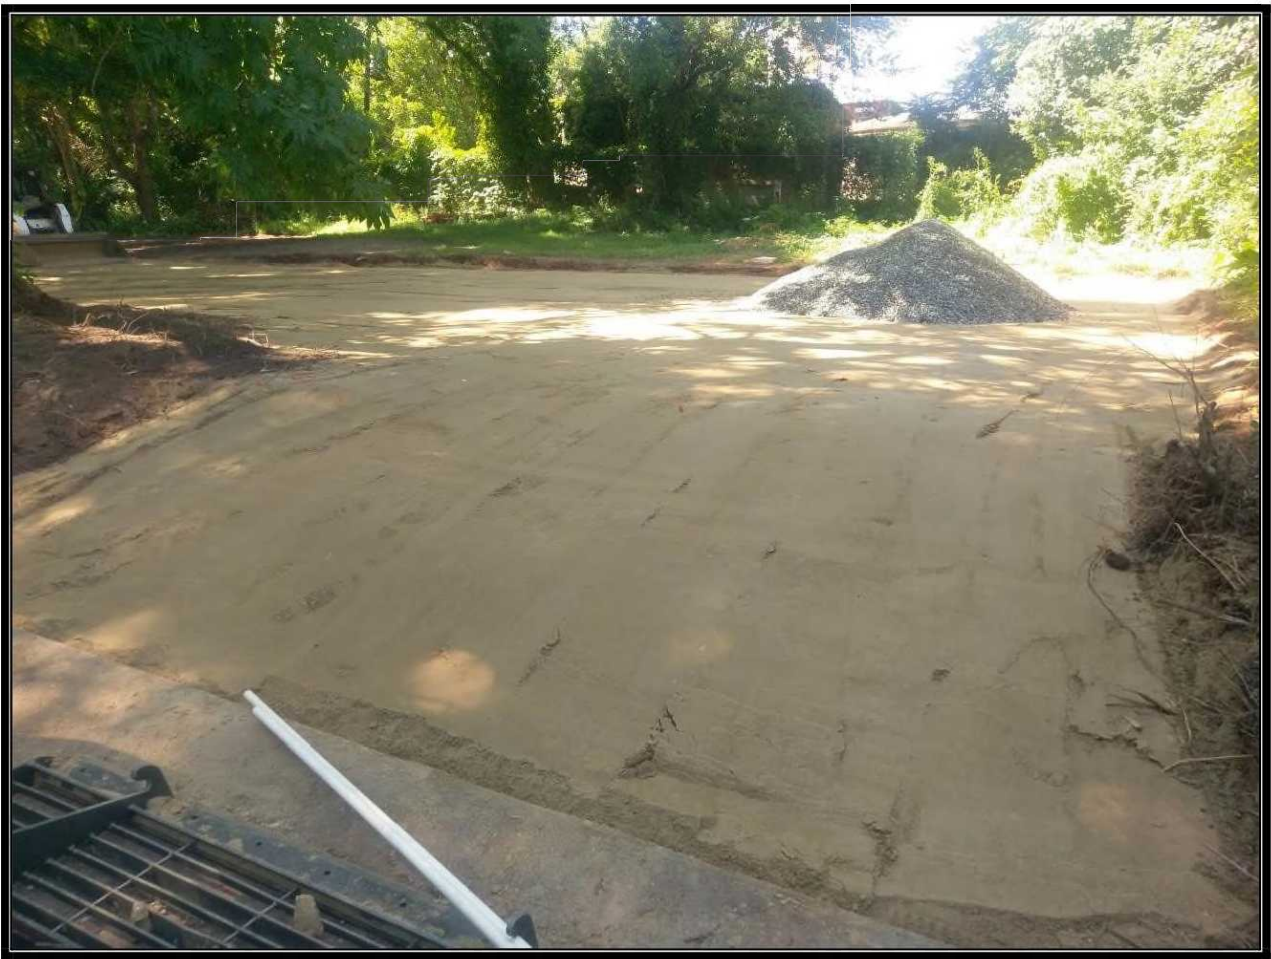
OFFICIAL PHOTOGRAPH NO. 5
U.S. ENVIRONMENTAL PROTECTION AGENCY

TDD Number:	TT-01-071	Location:	Davidson Asbestos
Orientation:	South	Date:	June 27, 2017
Photographer:	Paul Prys, Tetra Tech	Witness:	None
Subject:	ER used dump trucks and skid steers to install backfill in the excavated areas.

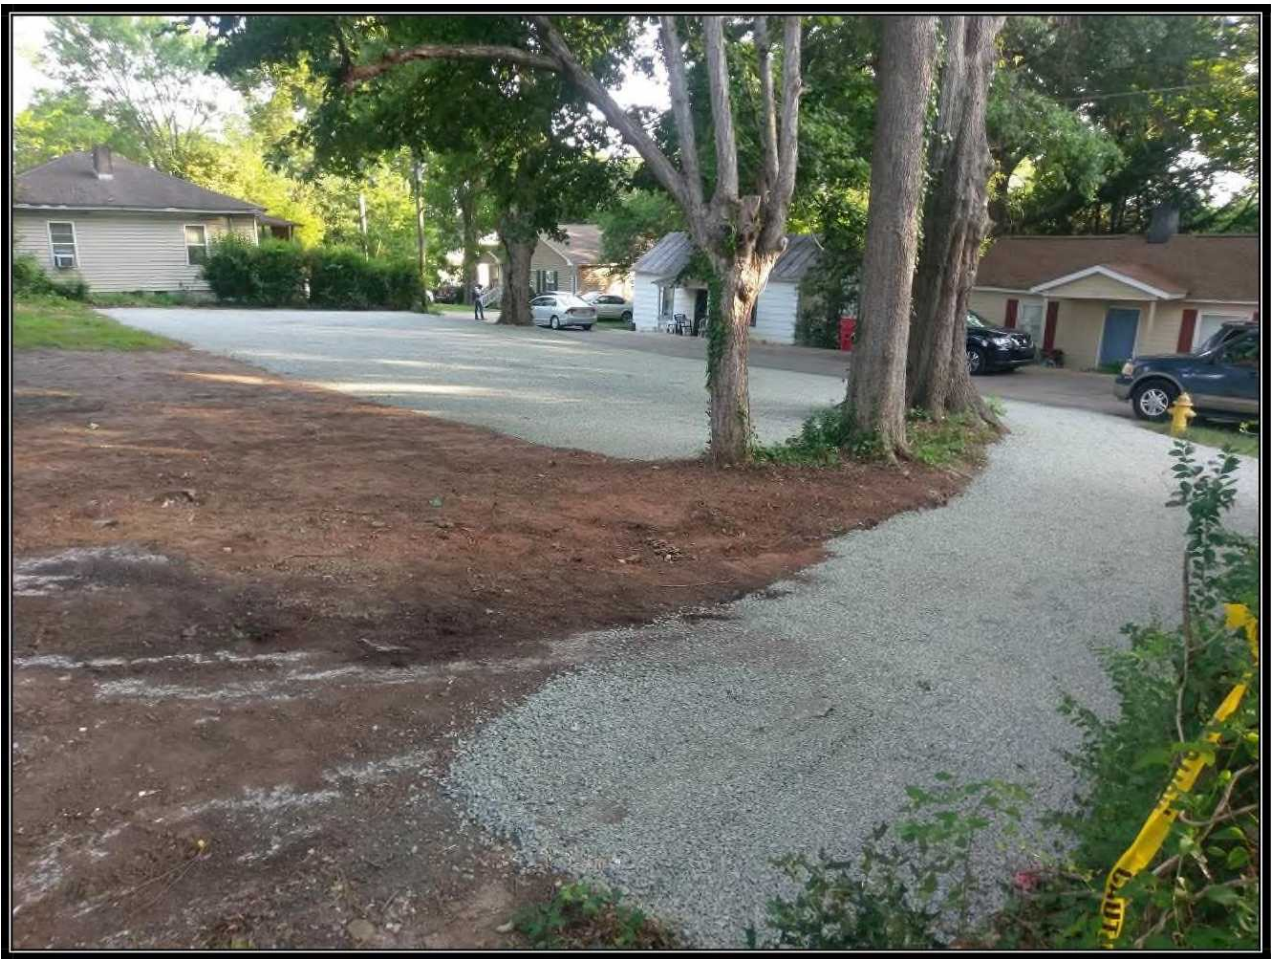
OFFICIAL PHOTOGRAPH NO. 6
U.S. ENVIRONMENTAL PROTECTION AGENCY

TDD Number:	TT-01-071	Location:	Davidson Asbestos
Orientation:	Northwest	Date:	June 29, 2017
Photographer:	Paul Prys, Tetra Tech	Witness:	None
Subject:	ER installed rock in the excavated areas after backfill installation was completed.
